REACTANCE
Power Engineering

Failure Investigation of a
50 MVA, 220/20 kV Power Transformer

Asset: 50 MVA 200/20 kV Power Transformer

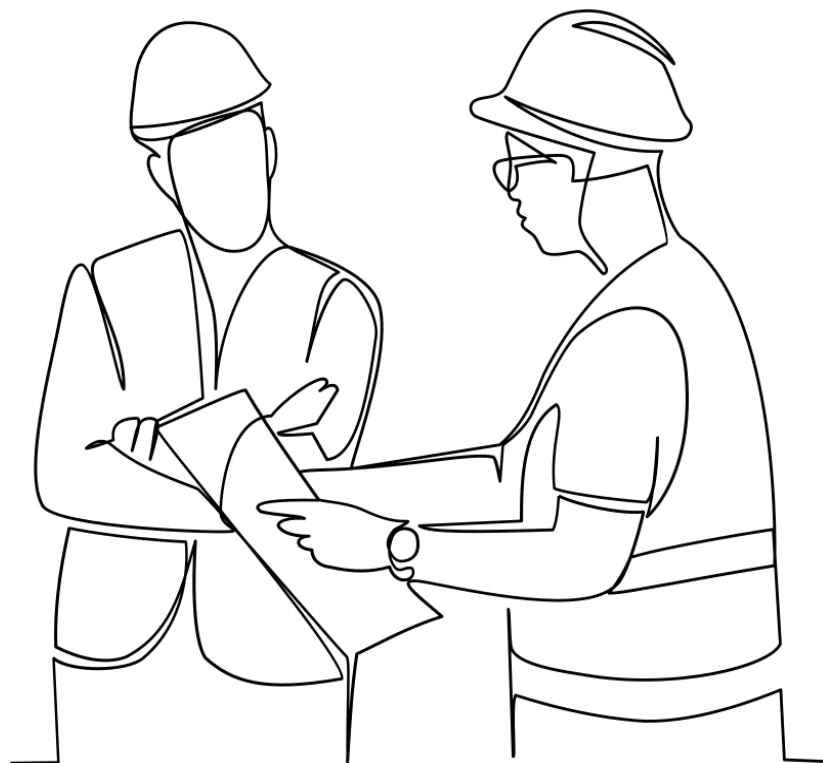
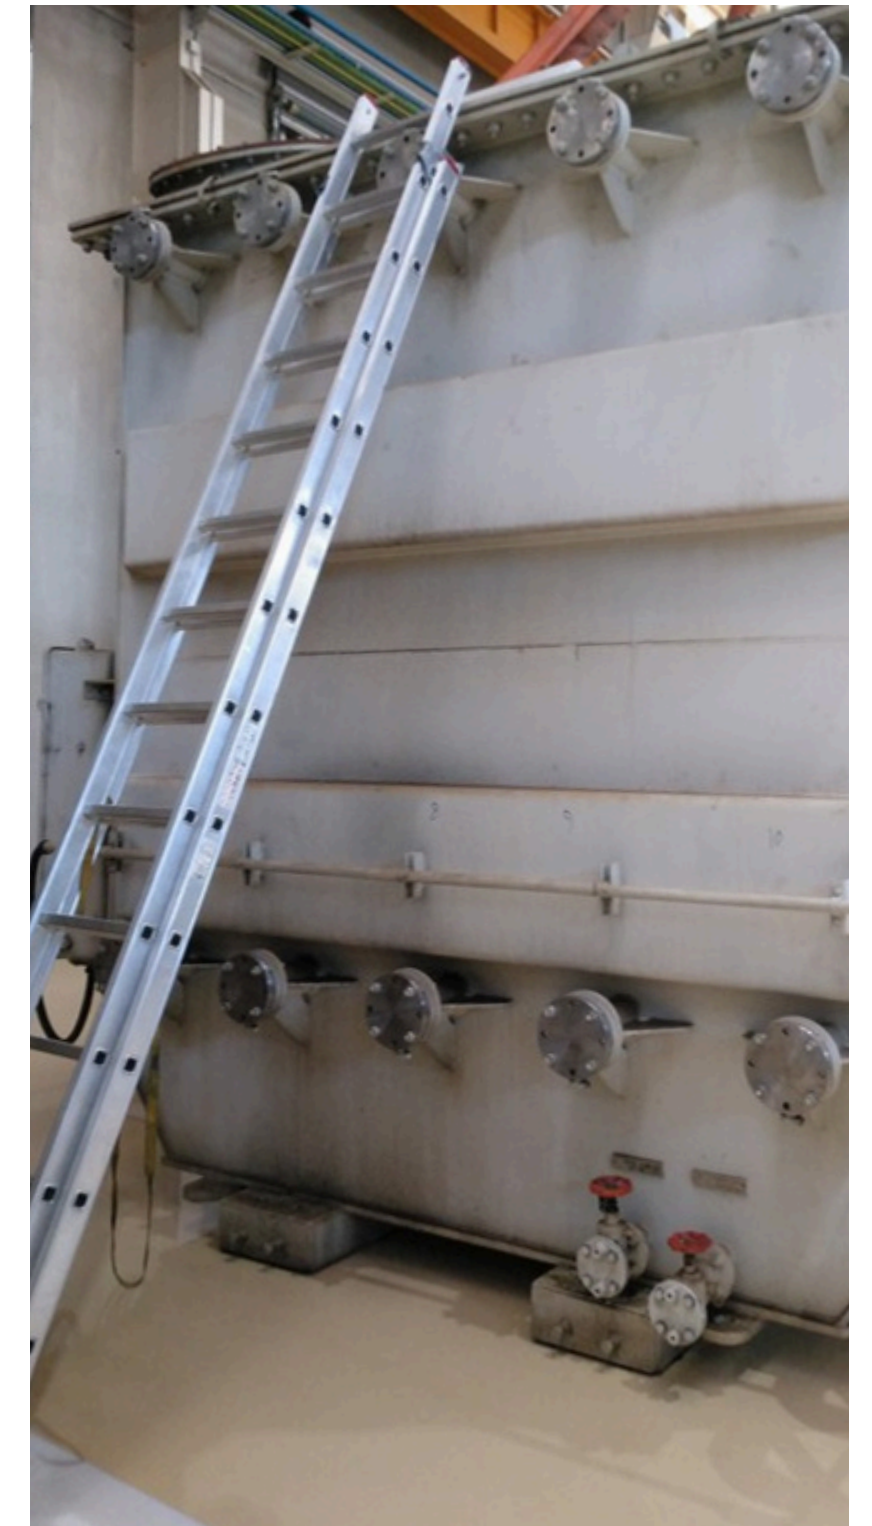
The unit tripped on differential protection, followed by a second event involving OLTC surge, pressure relief, and Buchholz alarms.

Initial investigation revealed severe damage: a bulged main tank, cracked 245kV bushing flanges, and selector switches torn from their compartments.

The challenge lies in conflicting root cause theories. While the OEM suggests electromagnetic forces from a short circuit caused the failure, site evidence — including arcing patterns and the absence of fault current in certain HV phases — points toward a mechanical failure of the OLTC connection plate as the primary initiator.

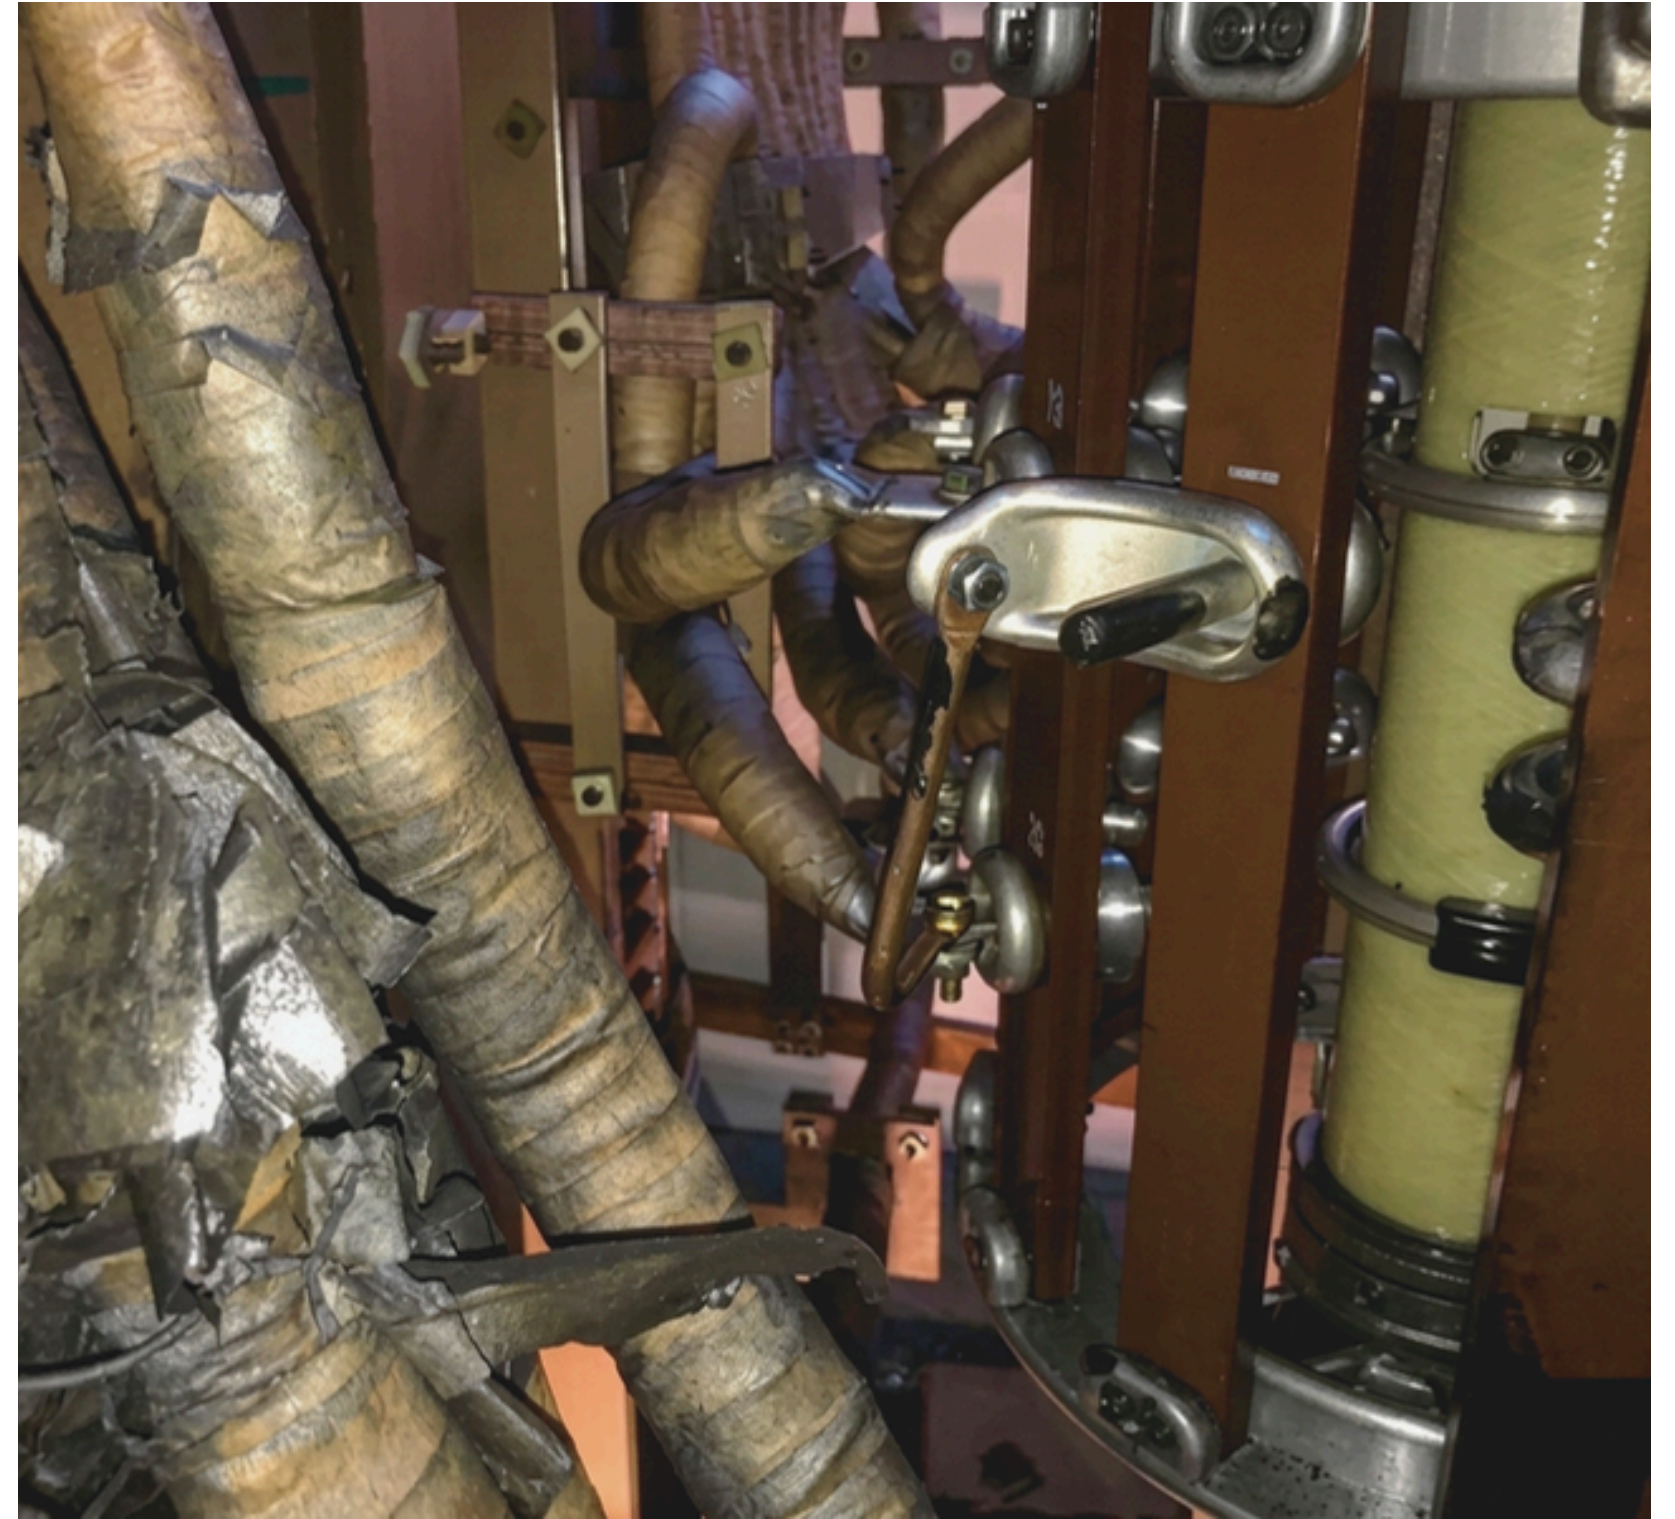
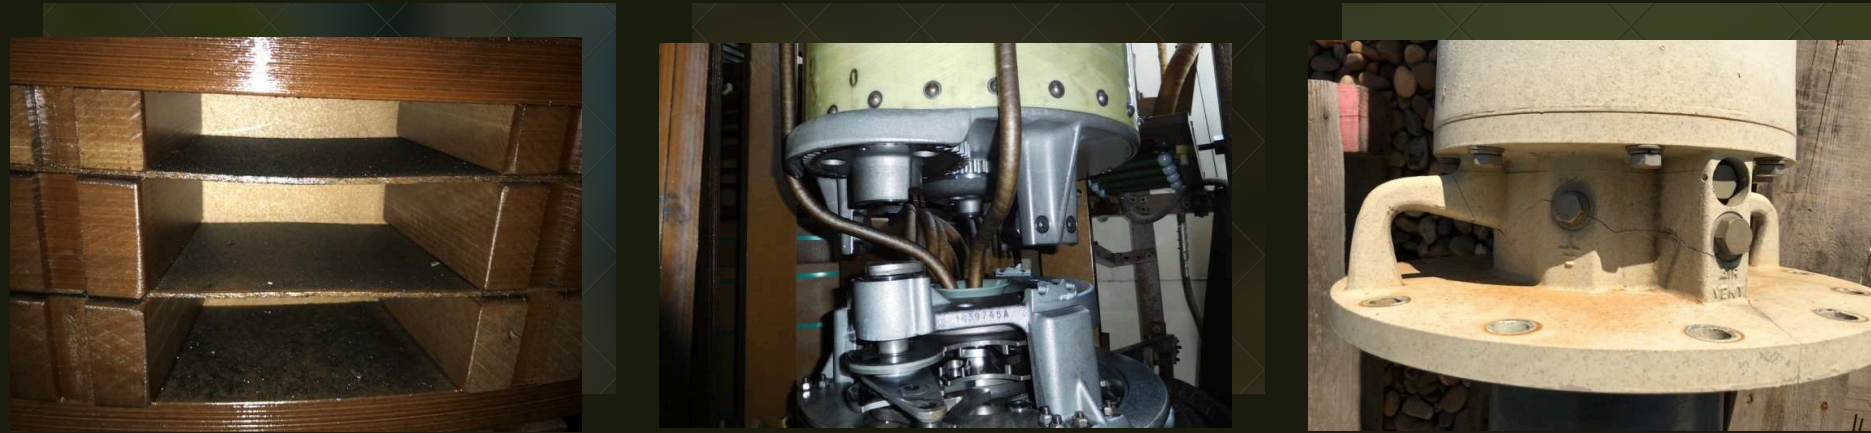
- Internal inspection revealed extreme carbonization and blackish oil.
- Pole A's selector switch was found broken and hanging, with significant arcing marks on the V-phase tap winding leads.
- Multiple support structures for tap leads and tie-in resistors were fractured. Externally, the impact of high internal pressure was evident through bulged tank walls and cracked bushing mounting flanges.
- DGA results confirmed high-energy arcing, showing massive spikes in Hydrogen (265 ppm), Ethylene (1321 ppm), and Acetylene (1203 ppm).
- Despite the physical destruction of the OLTC and accessories, electrical ratio, magnetization, and winding resistance tests remained within tolerance, suggesting the core and main windings themselves were not permanently damaged during the event.

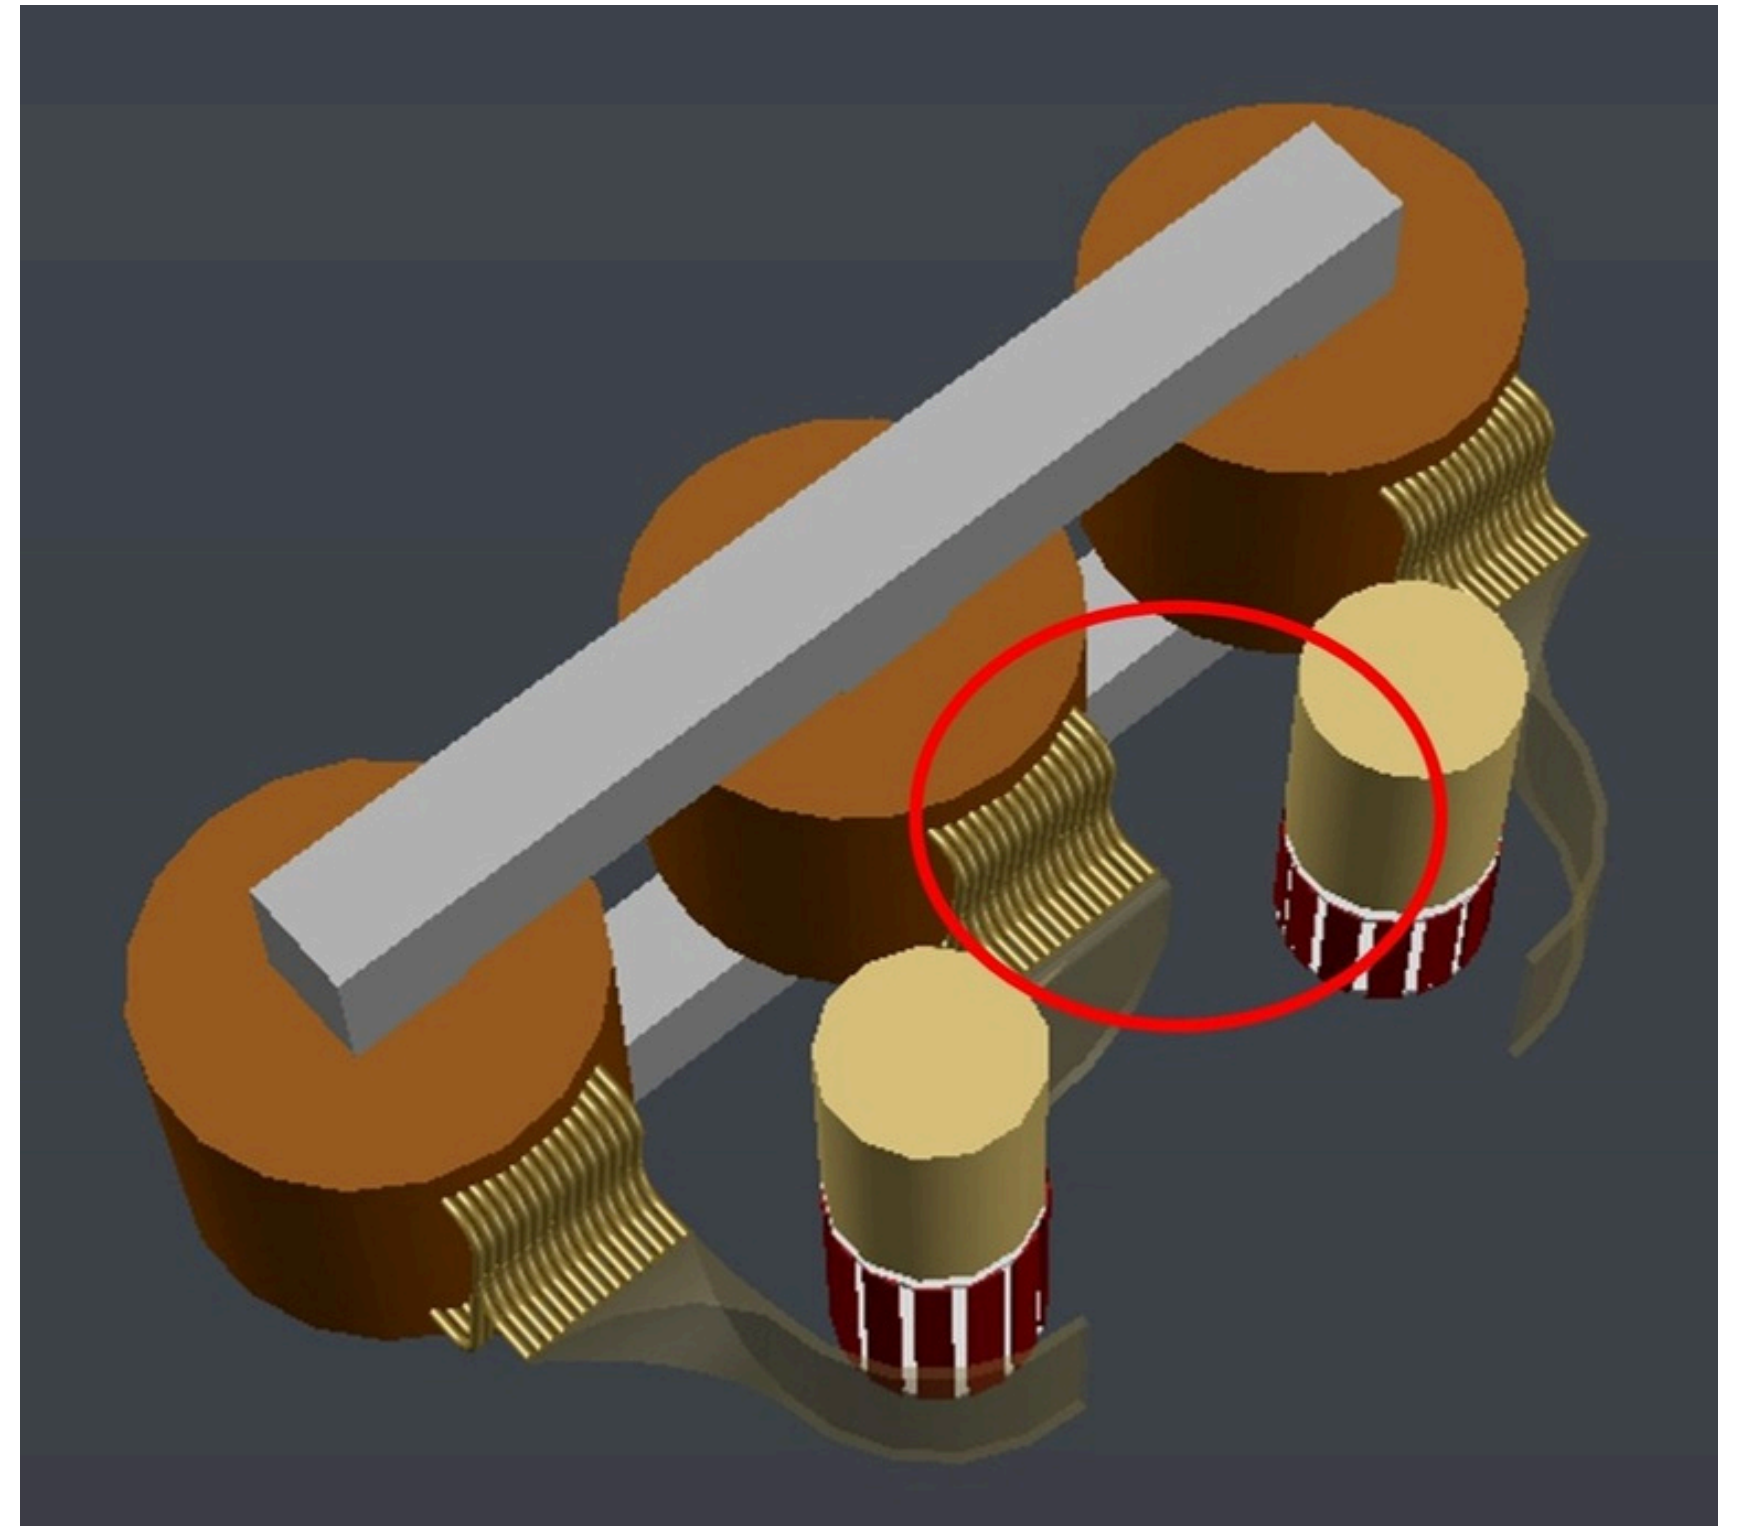
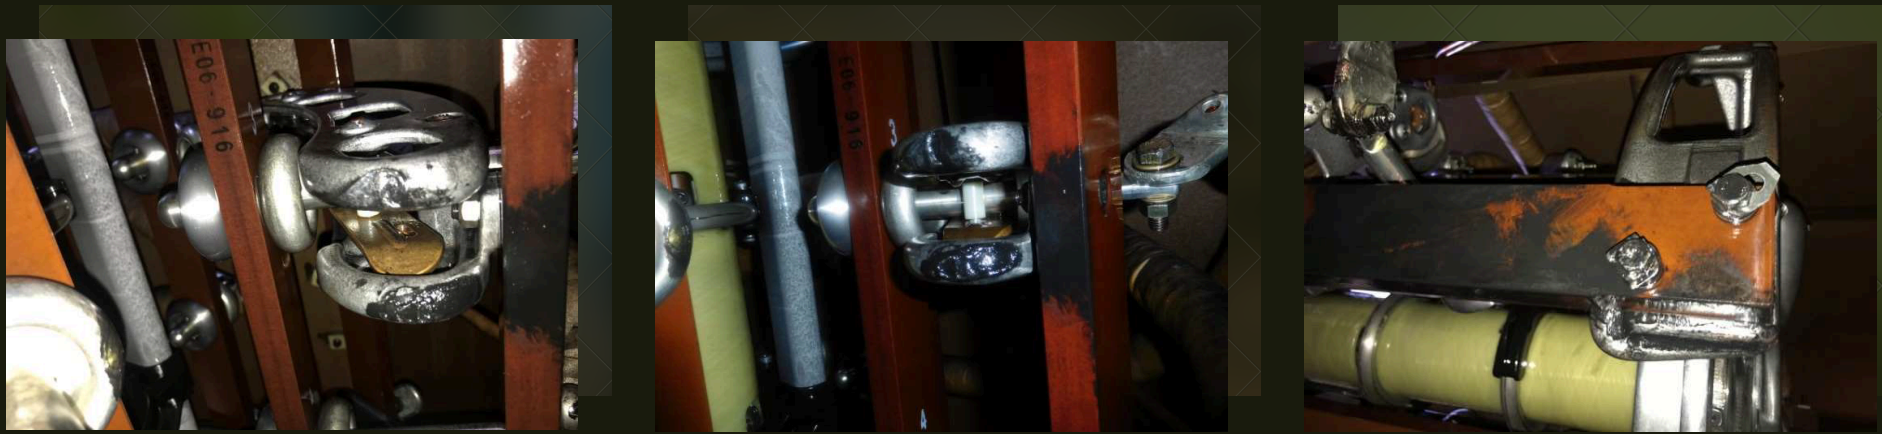
- OEM posits that a short circuit current generated high electromagnetic forces, leading to selector failure.
- However, HV current waveforms show zero fault current in the W-leg winding, contradicting OEM's theory of a "short circuit via the whole tap winding."
- Analysis of the arcing marks suggests a different failure mode: the mechanical breaking of a connection plate inside the OLTC oil compartment. This failure likely left components electrically floating, creating potential differences higher than acceptable limits and triggering a flashover.
- The resulting arcing generated the rapid gas and pressure that caused the tank bulging, bushing flange cracks, and subsequent protection relay operations.
