Revision of Single-Phase 420kV
Autotransformer OLTC Assembly

CASE STUDY

Mitigation of Local Overheating and Oil Decomposition
in a Single-Phase Autotransformer OLTC Assembly

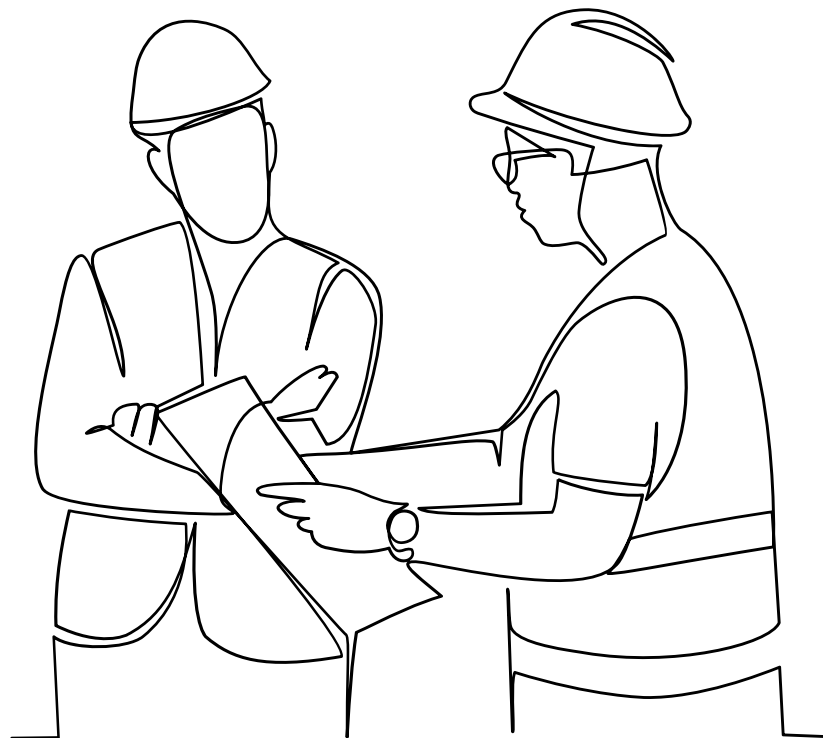
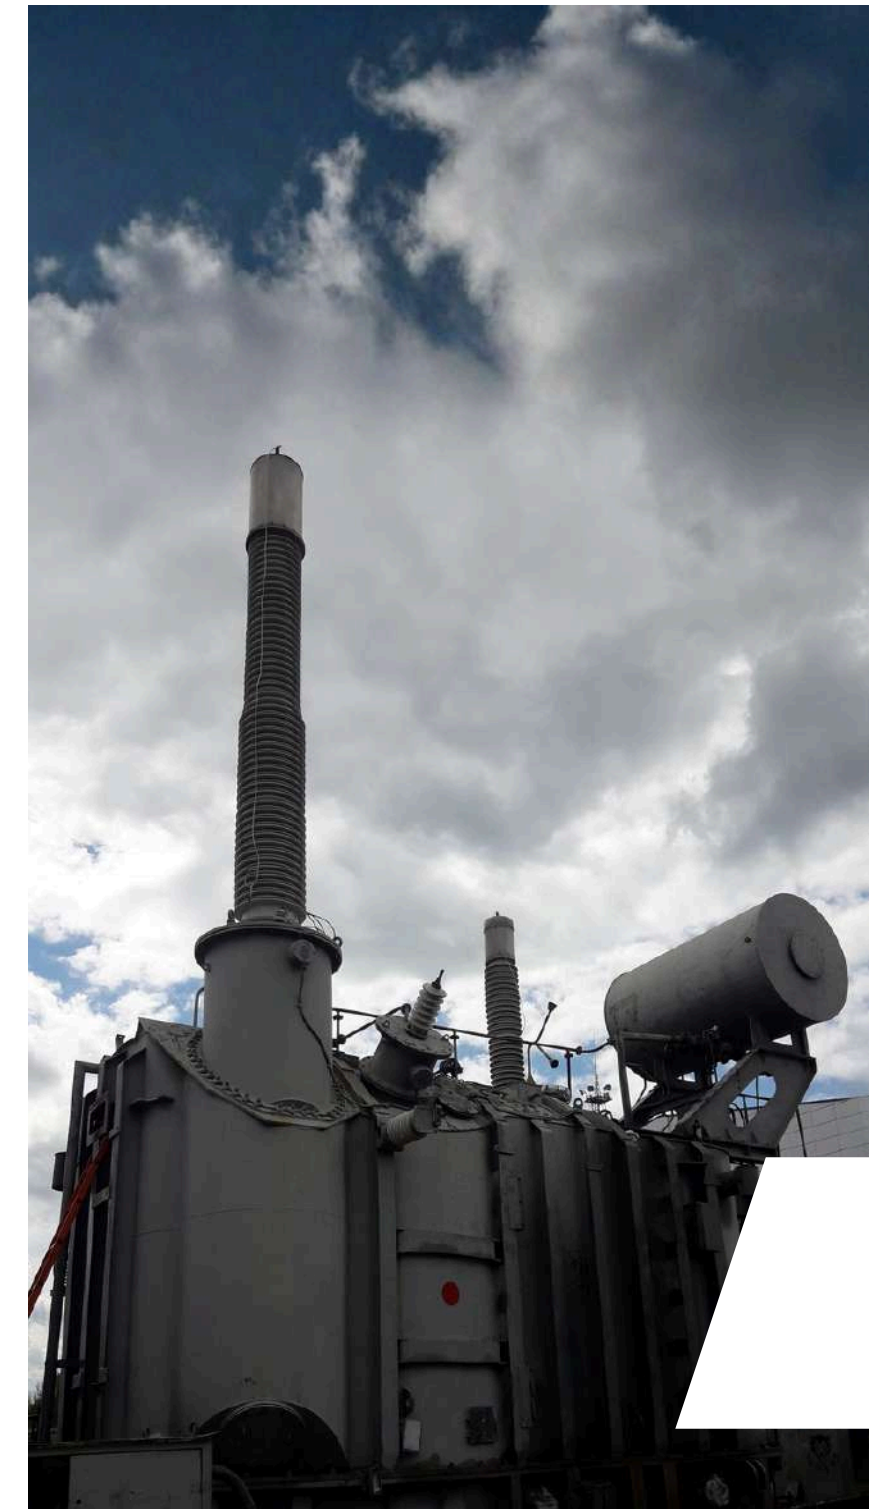
Observations:

- Carbonization traces and oil discoloration in the OLTC mechanical console area
- Evidence of thermal stress (overheating marks on metallic parts)
- No direct current-carrying components in immediate contact with the affected area

The OLTC console consists of two metallic parts:

- One part connected to a defined electrical potential
- Another part floating (not grounded) and located in close proximity

This configuration created:

- Capacitive coupling between conductive parts
- Potential difference leading to circulating currents or partial discharges
- Resulting localized heating and oil degradation
