REACTANCE
Power Engineering

Failure Investigation of a
50 MVA, 220/20 kV Power Transformer

Asset: 50 MVA 200/20 kV Power Transformer

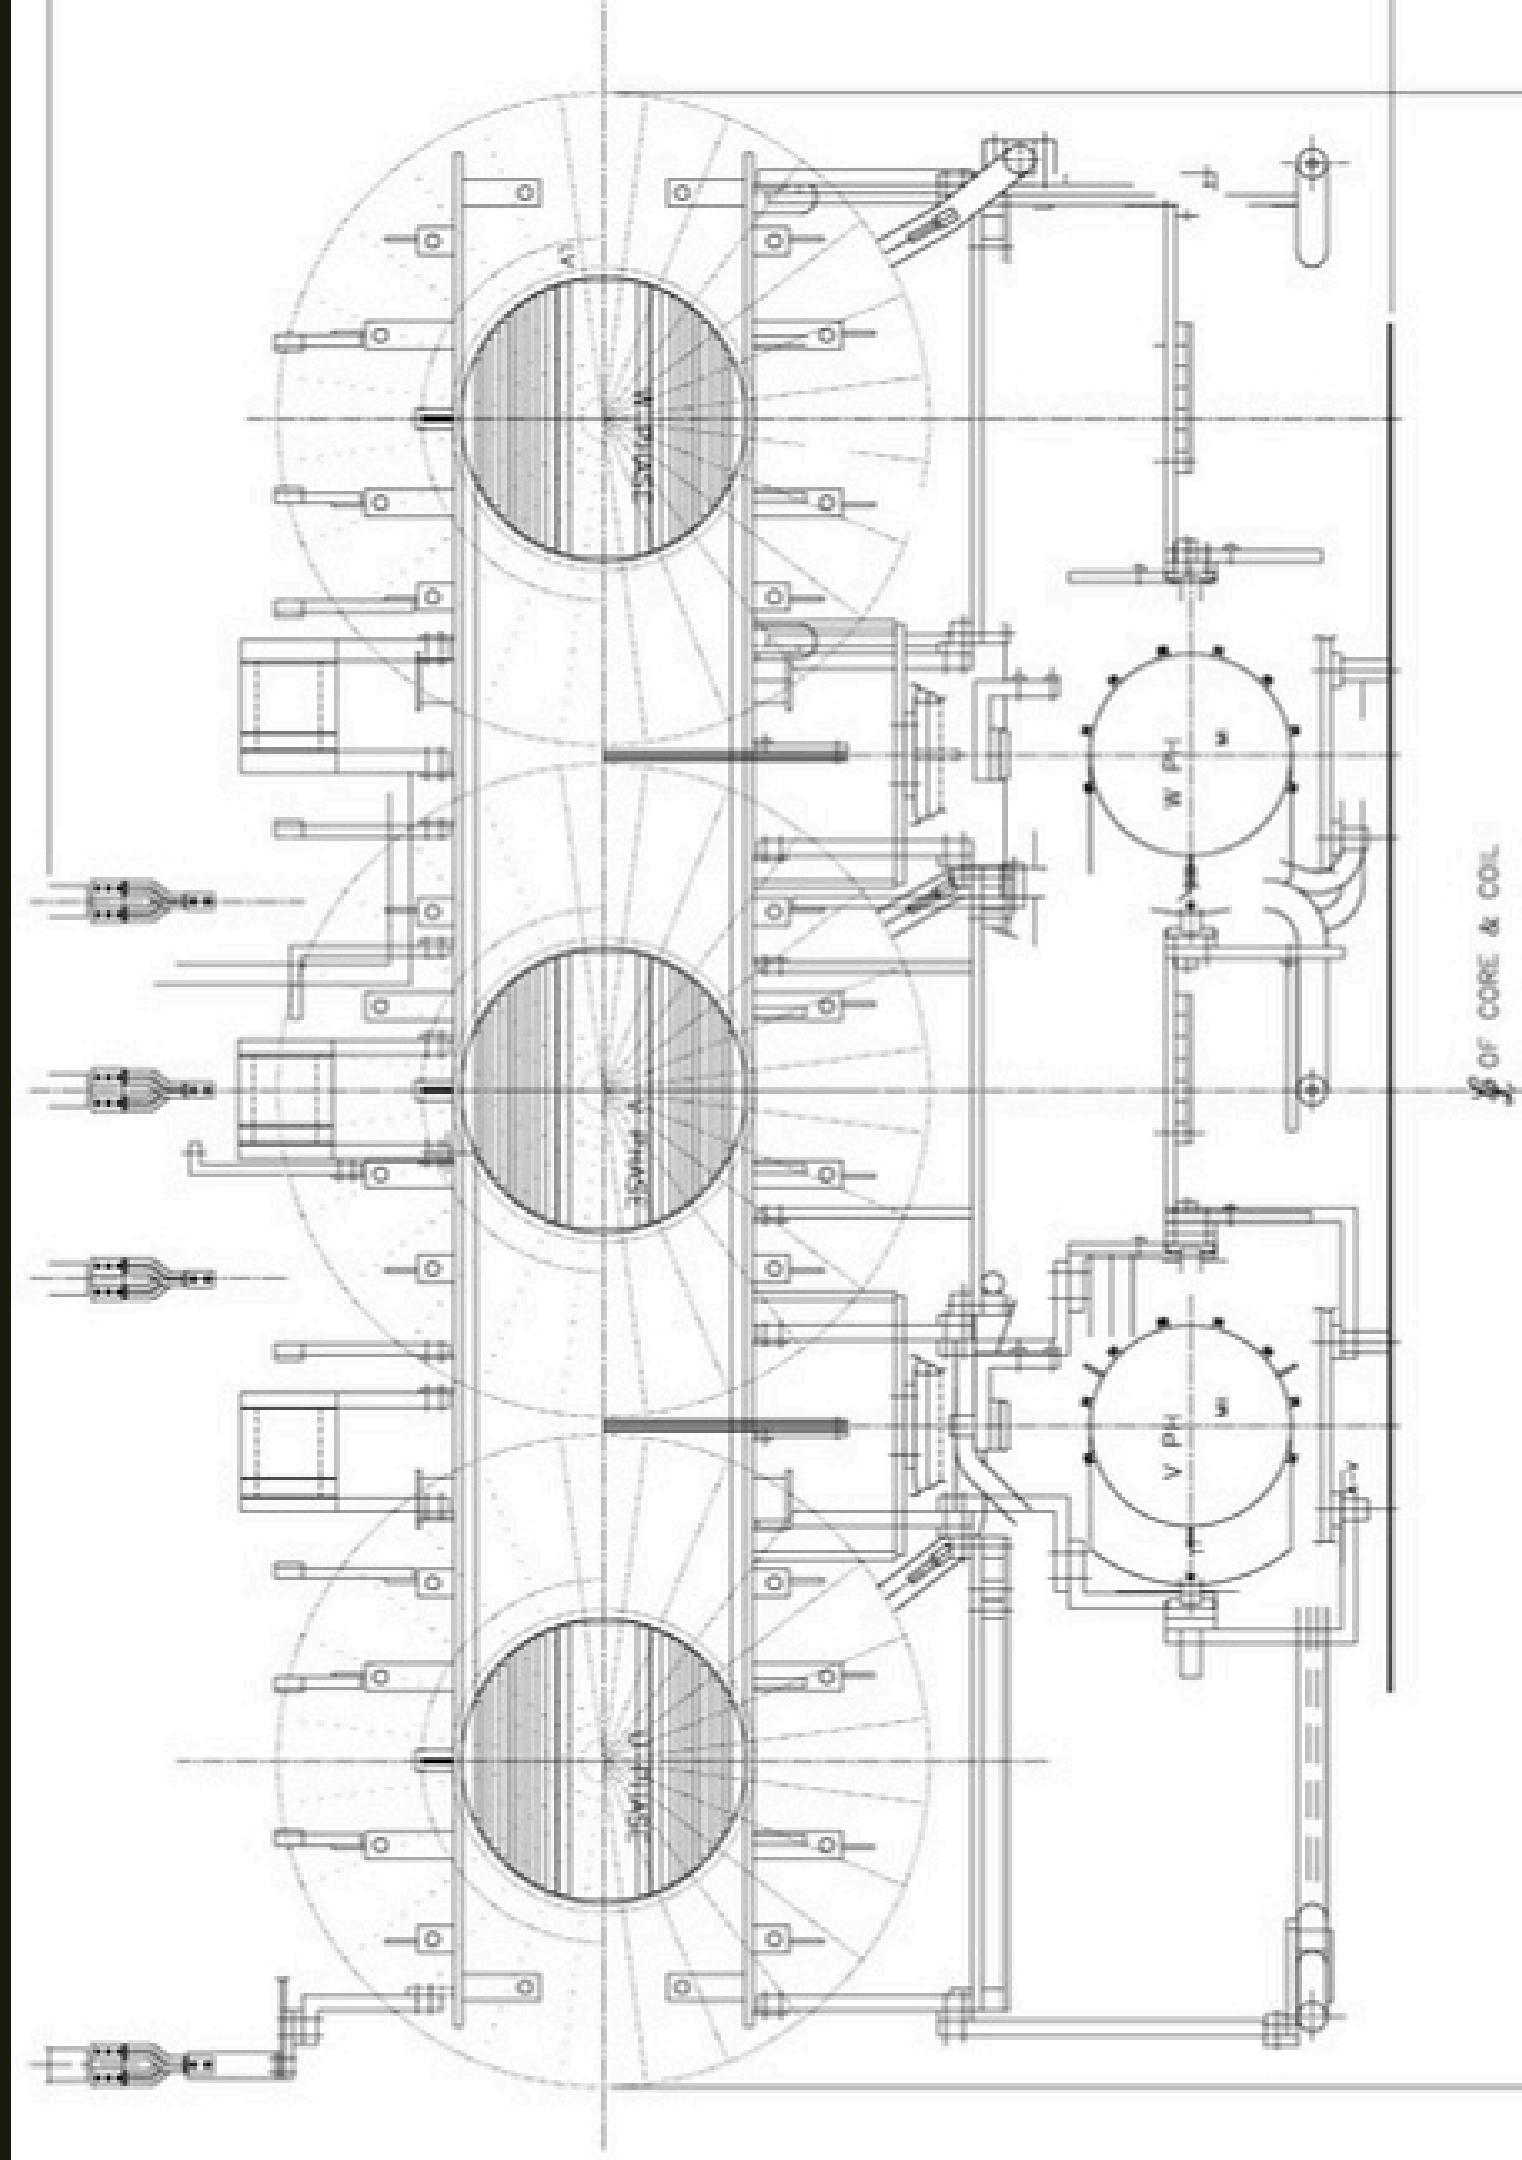
The process began with a analysis of legacy technical specifications, review of original dimensional drawing, rating plate and test report.

- Internal inspection revealed extreme carbonization and blackish oil.
- Pole A's selector switch was found broken and hanging, with significant arcing marks on the V-phase tap winding leads.
- Multiple support structures for tap leads and tie-in resistors were fractured. Externally, the impact of high internal pressure was evident through bulged tank walls and cracked bushing mounting flanges.
- DGA results confirmed high-energy arcing, showing massive spikes in Hydrogen (265 ppm), Ethylene (1321 ppm), and Acetylene (1203 ppm).
- Despite the physical destruction of the OLTC and accessories, electrical ratio, magnetization, and winding resistance tests remained within tolerance, suggesting the core and main windings themselves were not permanently damaged during the event.

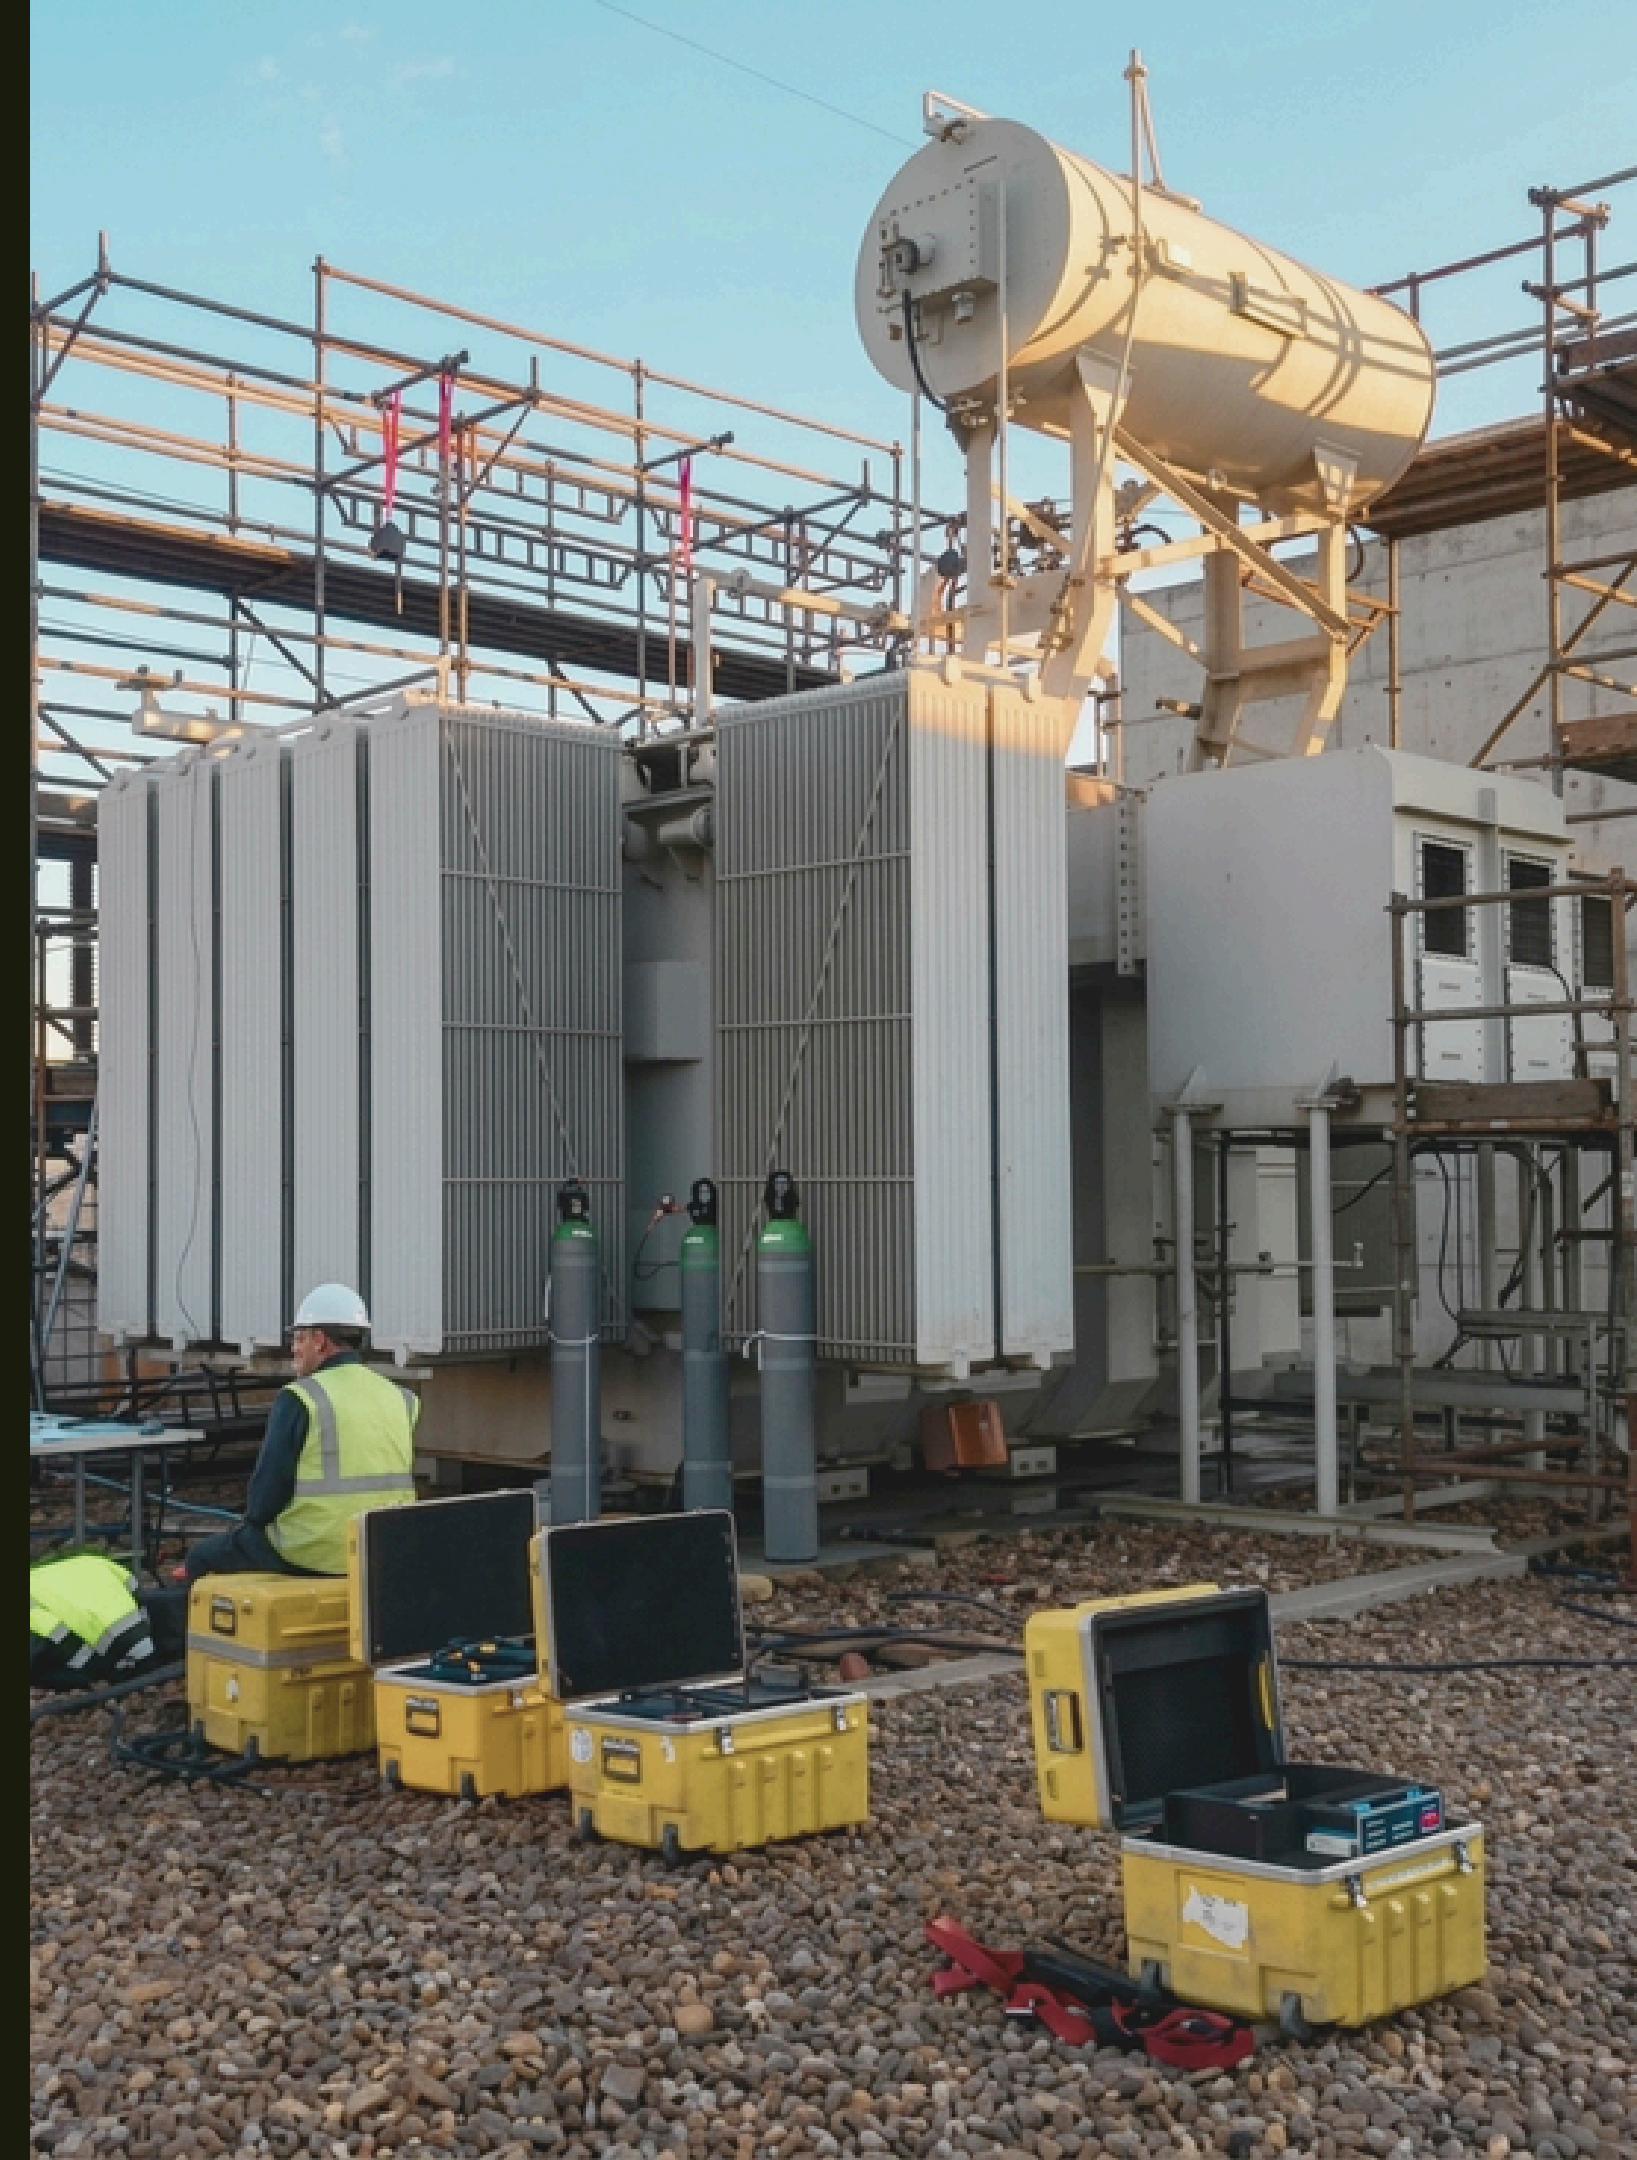
A critical discrepancy exists between the OEM and the Reactance Power Engineering analysis.

- OEM posits that a short circuit current generated high electromagnetic forces, leading to selector failure.
- However, HV current waveforms show zero fault current in the W-leg winding, contradicting OEM's theory of a "short circuit via the whole tap winding."
- Analysis of the arcing marks suggests a different failure mode: the mechanical breaking of a connection plate inside the OLTC oil compartment. This failure likely left components electrically floating, creating potential differences higher than acceptable limits and triggering a flashover.
- The resulting arcing generated the rapid gas and pressure that caused the tank bulging, bushing flange cracks, and subsequent protection relay operations.
